Inspection Report

Mine Name: Blind Stream
Operator Name: Shamrock Mining Associates

Permit number: S0130004
Inspection Date: September 12, 2007
Time: 8:40-9:40 AM

S0130004, Blind Stream Mine, Shamrock Mining Associates

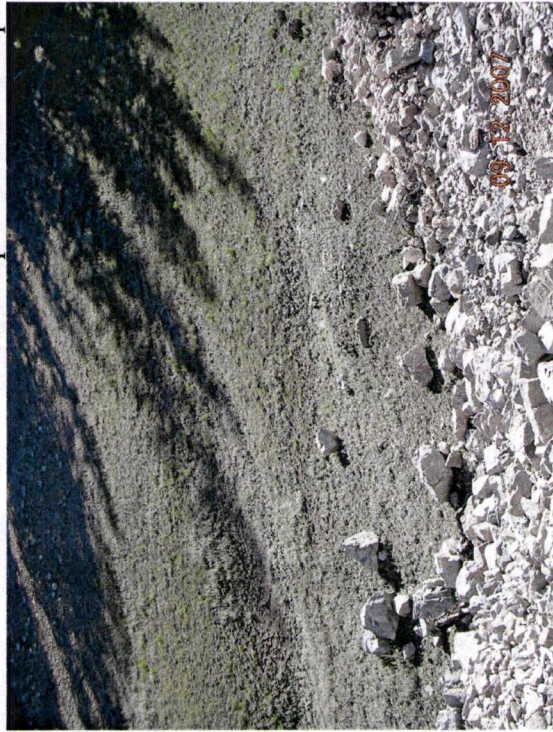
There are limited soils in most of the mine area, and the operator has salvaged and stockpiled some soil. There is a waste pile on the east side of the site which is partly over a low area where the soils appear to be deep (Photo 1). It does not appear that soil was salvaged in this area.

Photo 1. Looking down the waste pile. It does not appear soil was salvaged from the meadow at the base of the pile although it is probably available.

If the waste pile is expanded at all, the operator needs to salvage soil. Mr. North told me, however, that they are going to start putting waste in the pit (Photo 8), so the pile should be shrinking.

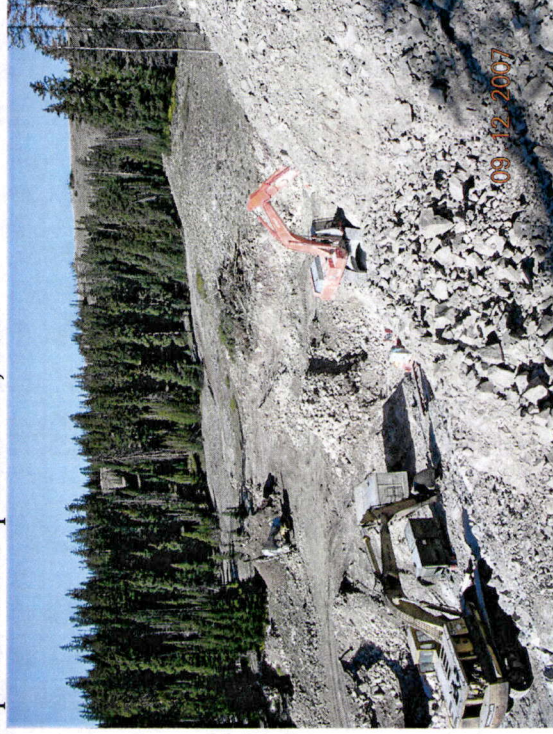
Photo 3. A view from above.

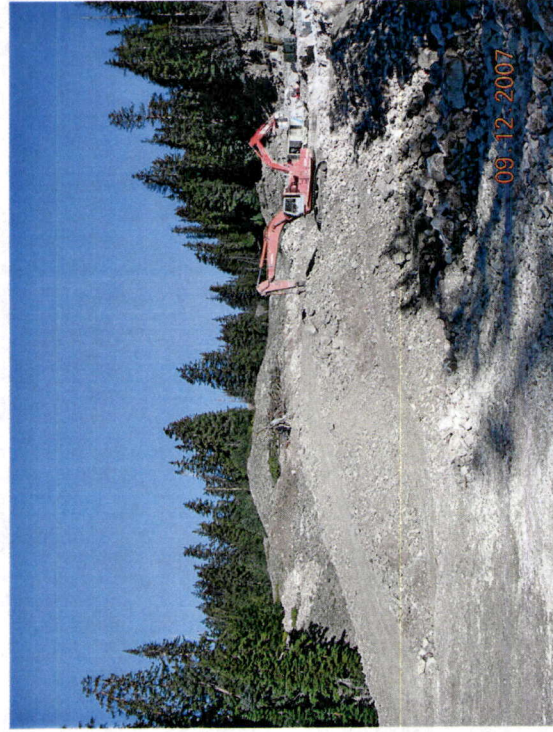
Photo 2. An overview of part of the mine site. This photo and Photo 4 make a panorama.

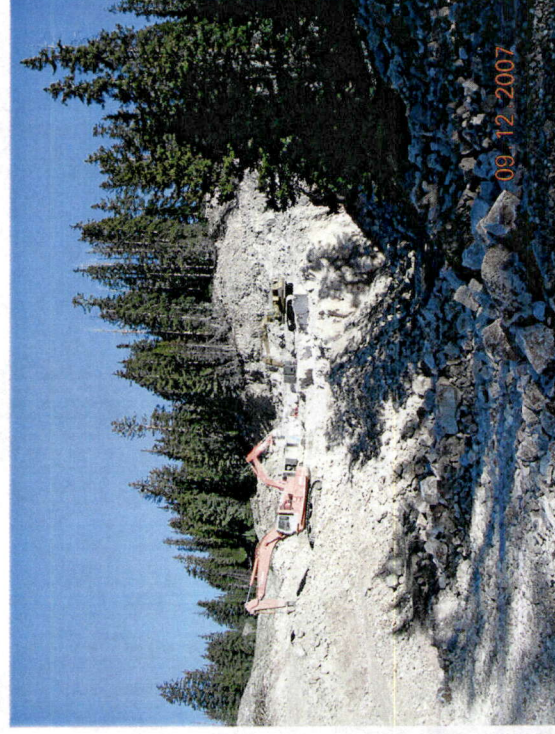
Photo 4. The original pit into which the operator intends to put waste rock is just to the right of center in this photo.

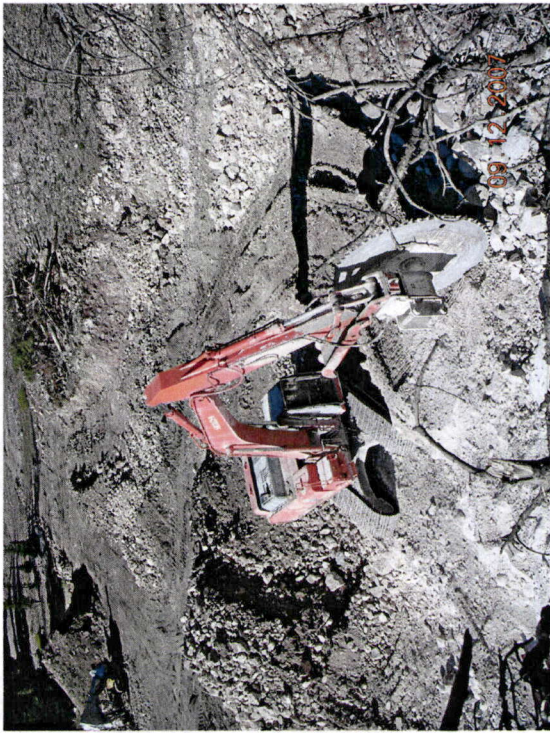
Photo 5. Photos 5-7 show some of the equipment. I had not previously seen a saw on a trackhoe like this.

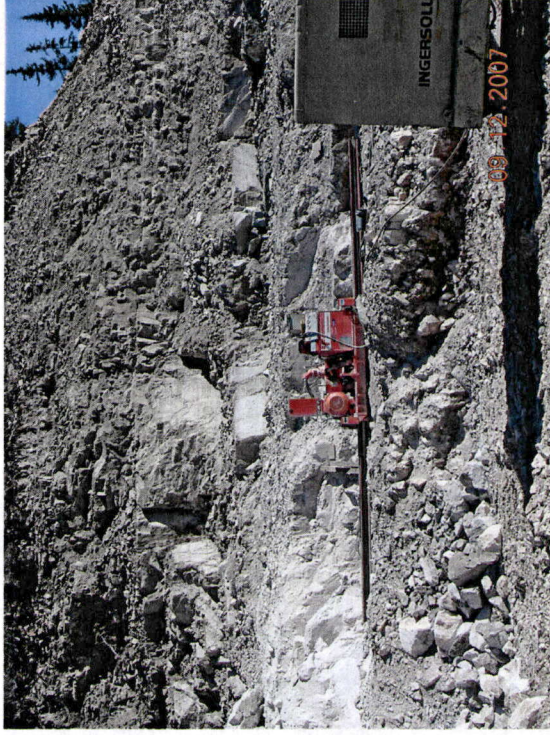
Photo 7. This is a saw for cutting horizontally.

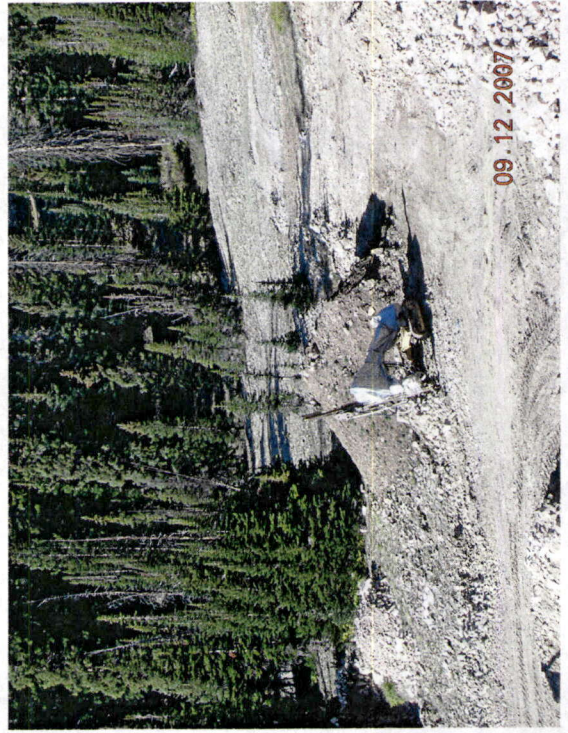
Photo 6. This is a drill.

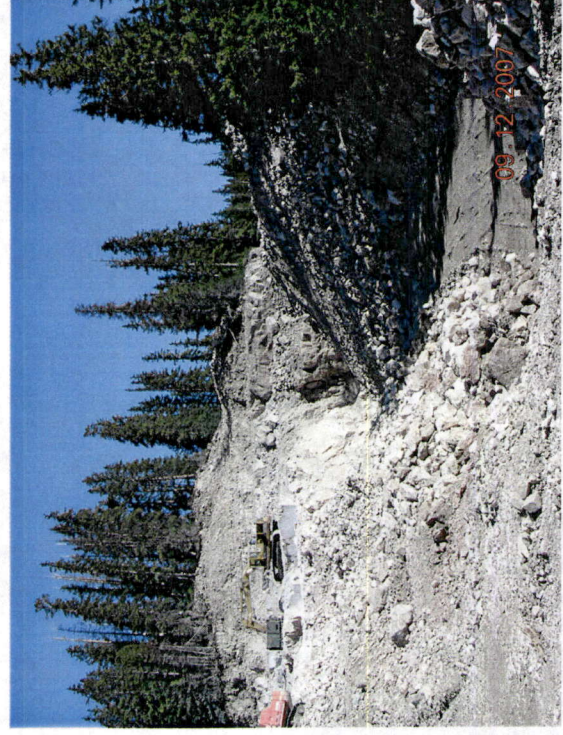
Photo 8. The operator intends to put waste rock in the pit shown near the center of this photo.
